**Lot 12 Mangrove Restoration Progress Report, March 2010****March 2, 2010 Report****OGC Case No.: 08-1930****2/22/10**

### Lot 12 Mangrove Restoration Progress Report, March 2010

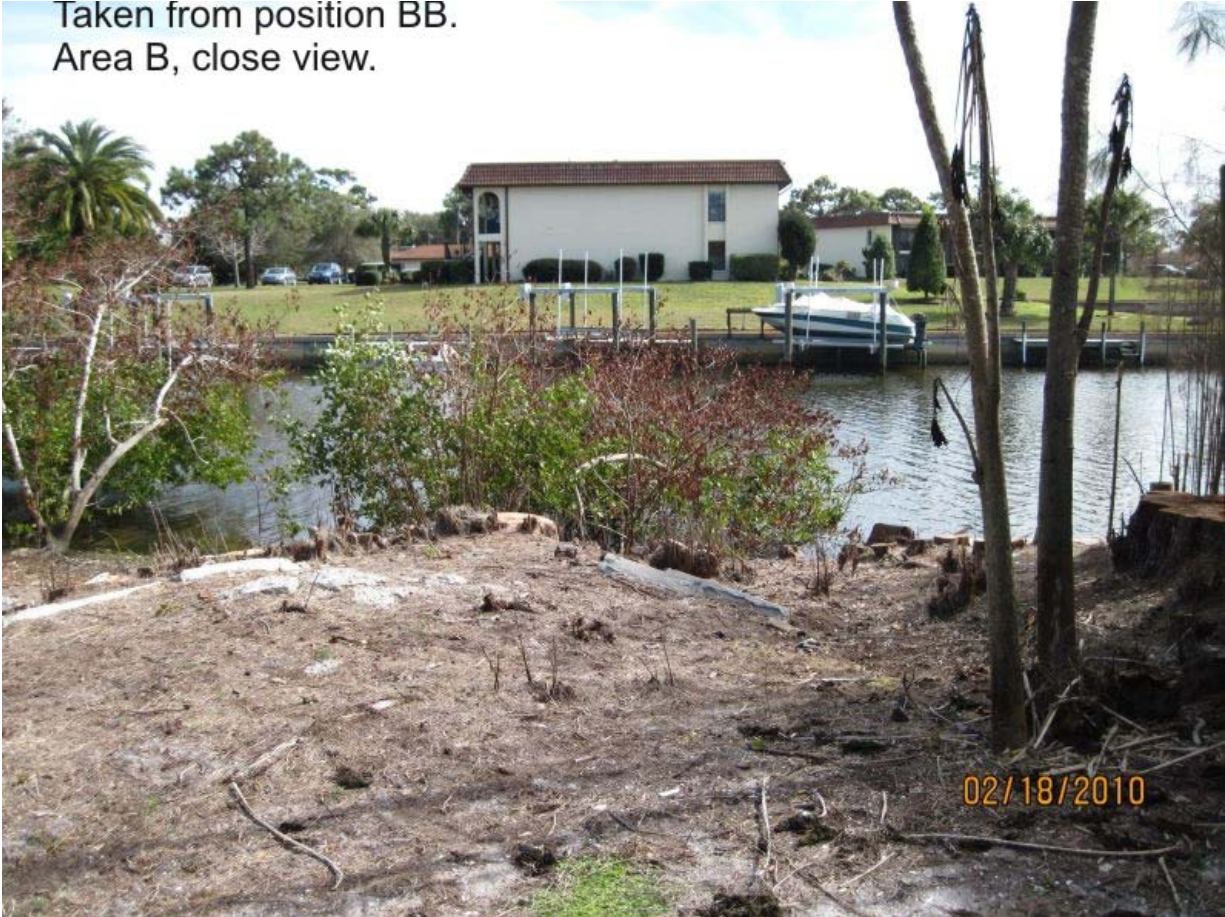
Taken from position BB.  
Area B, close view.

This was taken closer to the area where the large Australian pines have been removed. It was taken at position BB on the sketch, 16 ft. out from the gate jam post on the wood fence on the adjacent property.

Area B: The large Australian pines were removed using trucks, rigging lines, chippers, power tools, and hand tools. The stumps were drilled and stump killer inserted in the holes. Shoots and seedlings were sprayed with a systemic brush killer.

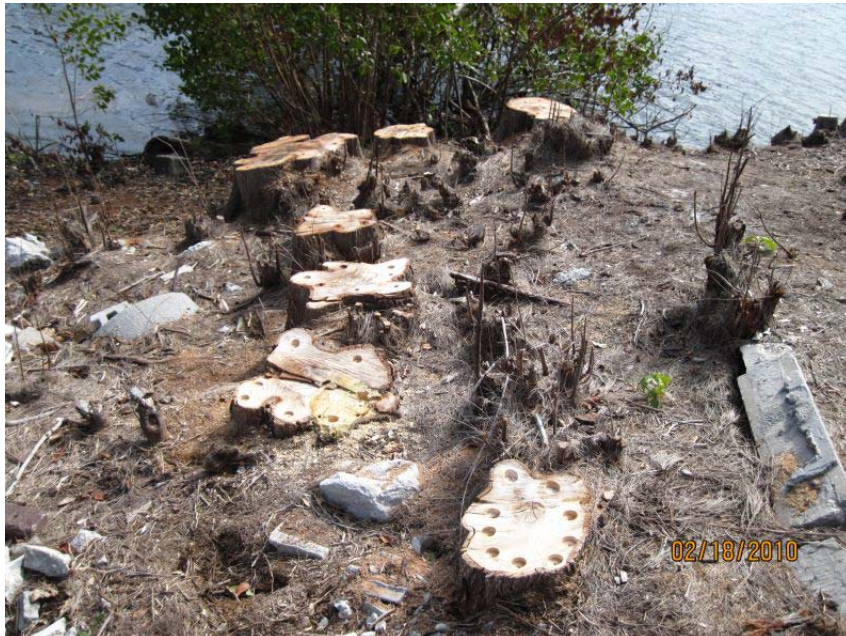
This is an additional photo to show how the large Australian pine stumps were drilled and filled with stump killer.

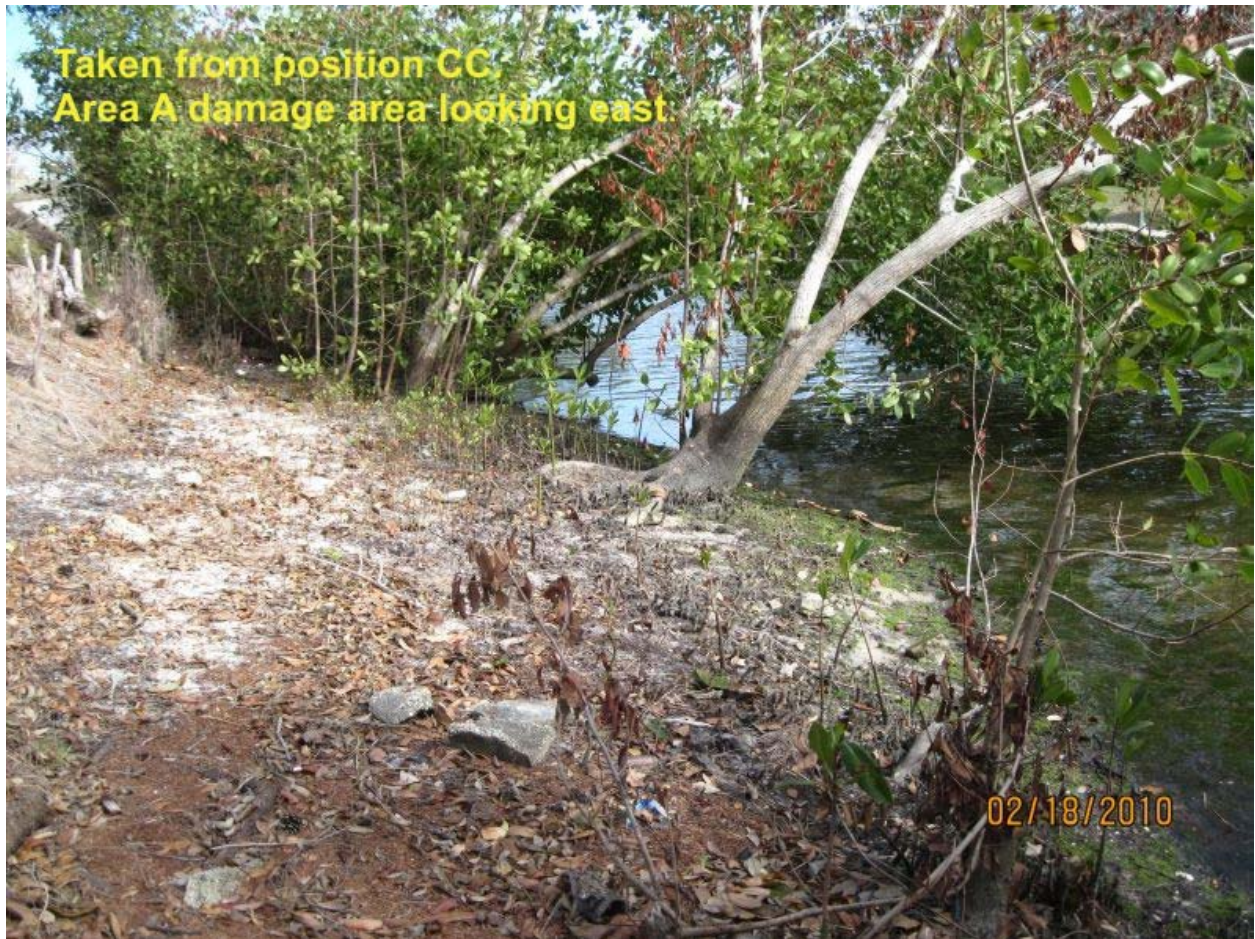
The height of the damaged mangroves ranges from about 3-23 inches. The percentage of cover is estimated to be less than 1 %. There appears to be significant frost damage resulting from the freezing temperatures three nights in a row in mid January.

This was taken at position CC, standing just above the low tide water line, leaning against the south most Australian pine at the west end of Area B. It shows the damage area in Area A.

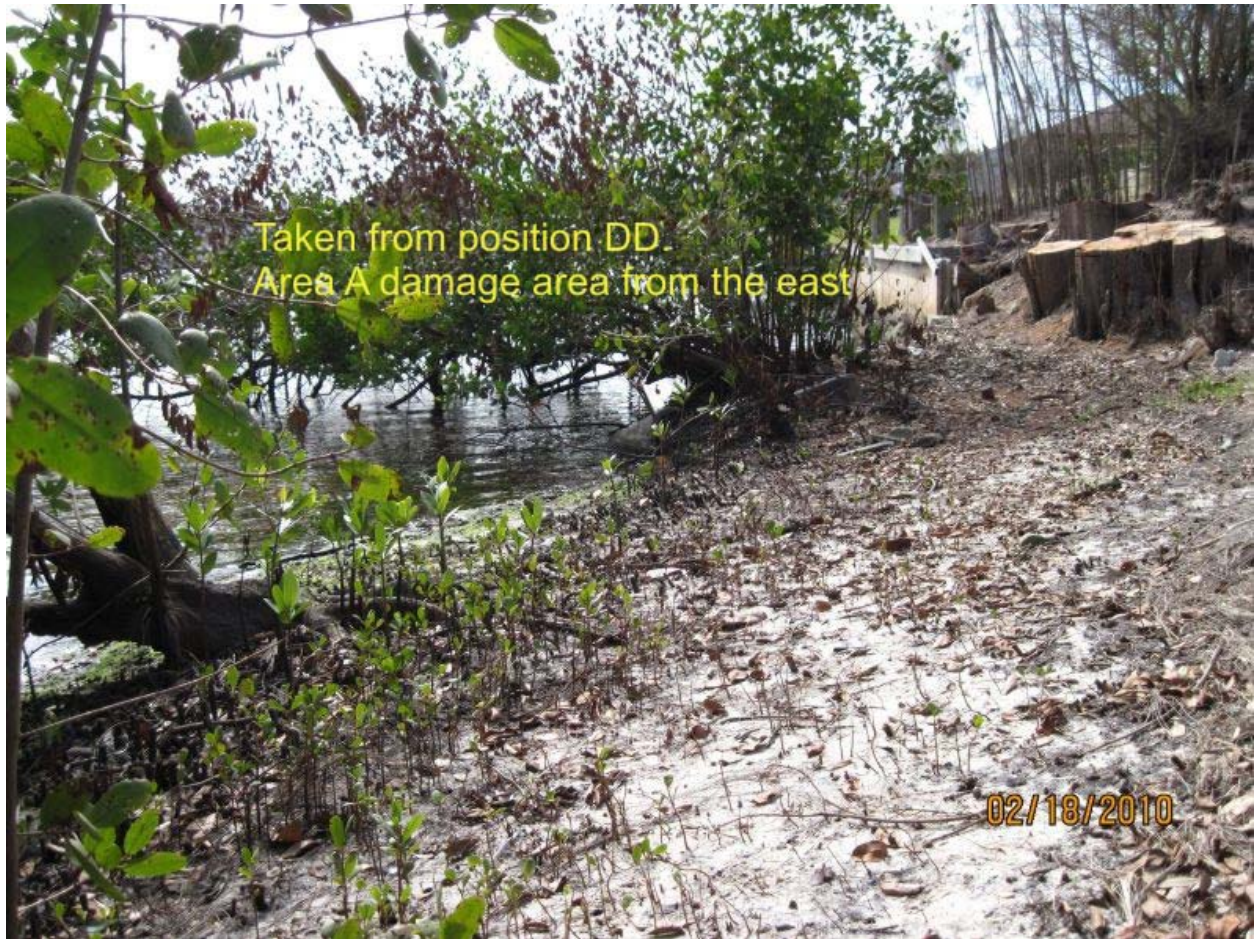
Same area of damaged mangroves as the previous photo but taken from the west at a position just below the oak tree on the bank at the east end of Area A, position DD on the sketch.
