Lot 12 Mangrove Restoration Progress Report**Time Zero Report****OGC Case No.: 08-1930****8/15/09**

Lot 12 Mangrove Restoration Progress Report

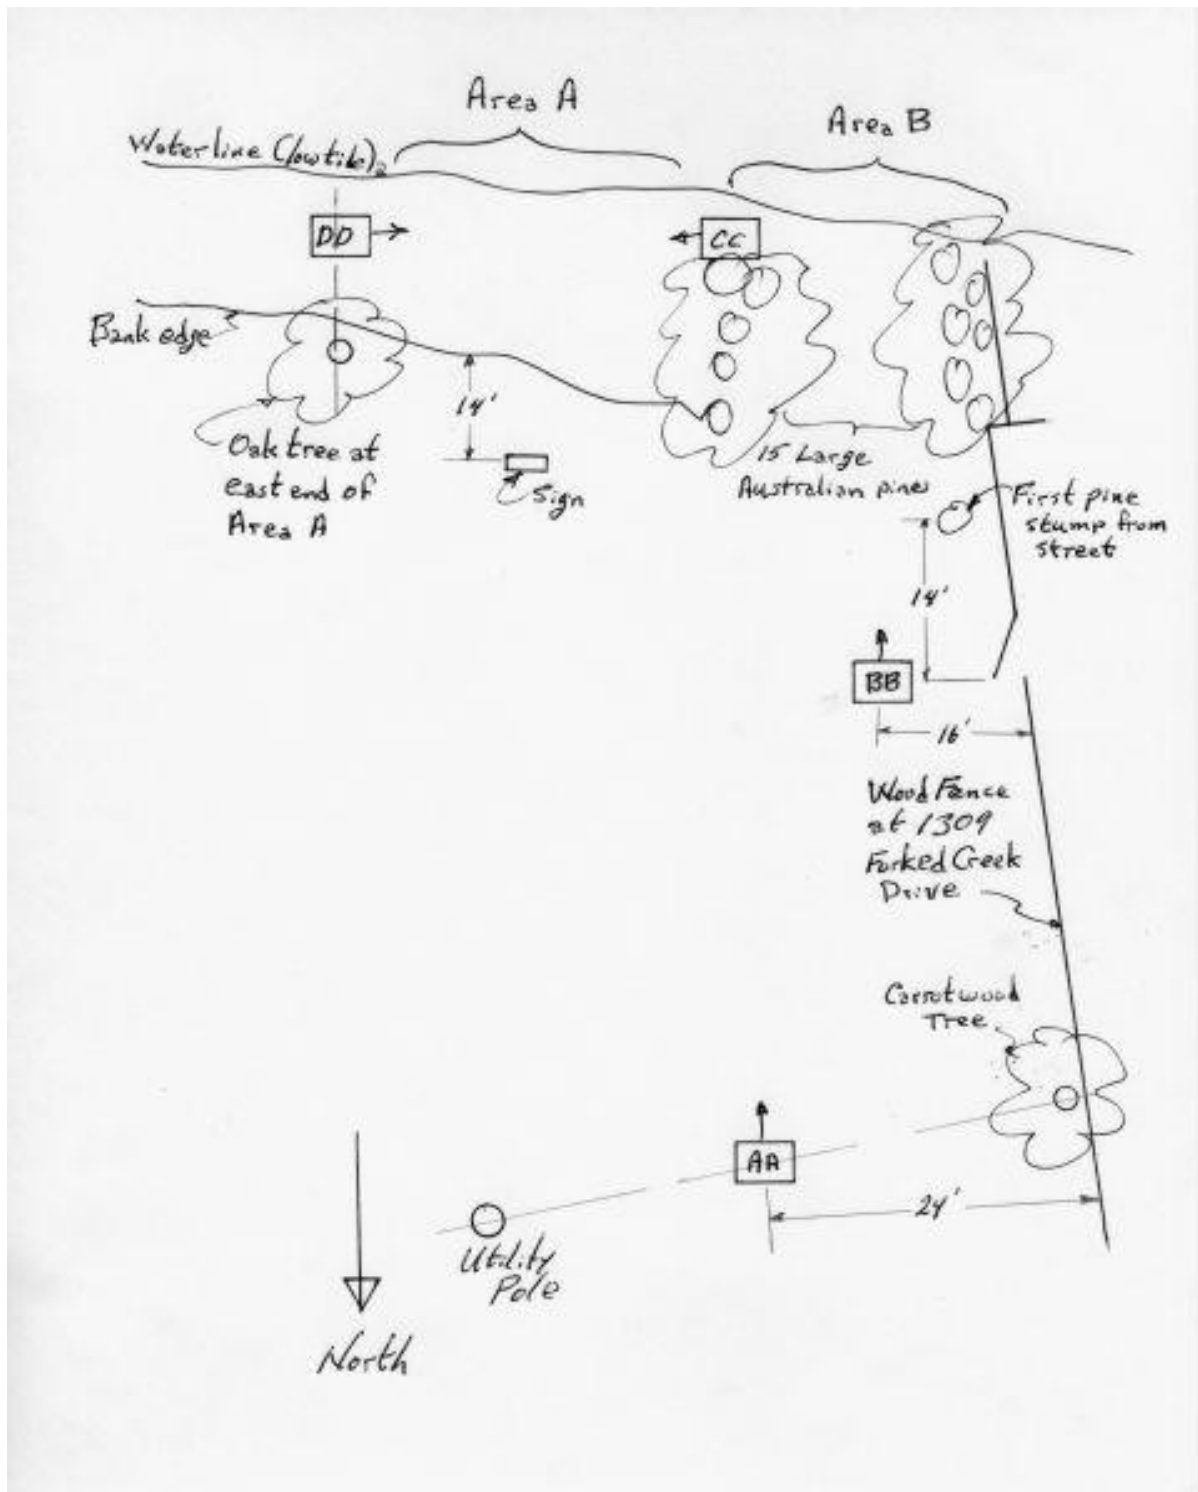
Sketch of Areas A and B showing the positions photos were taken from and the dimensions to the reference points. Positions AA and BB were used to show the large Australian pines as Area B is approached from the street. Positions CC and DD were taken at the low tide water line to show the details of the damaged mangroves.

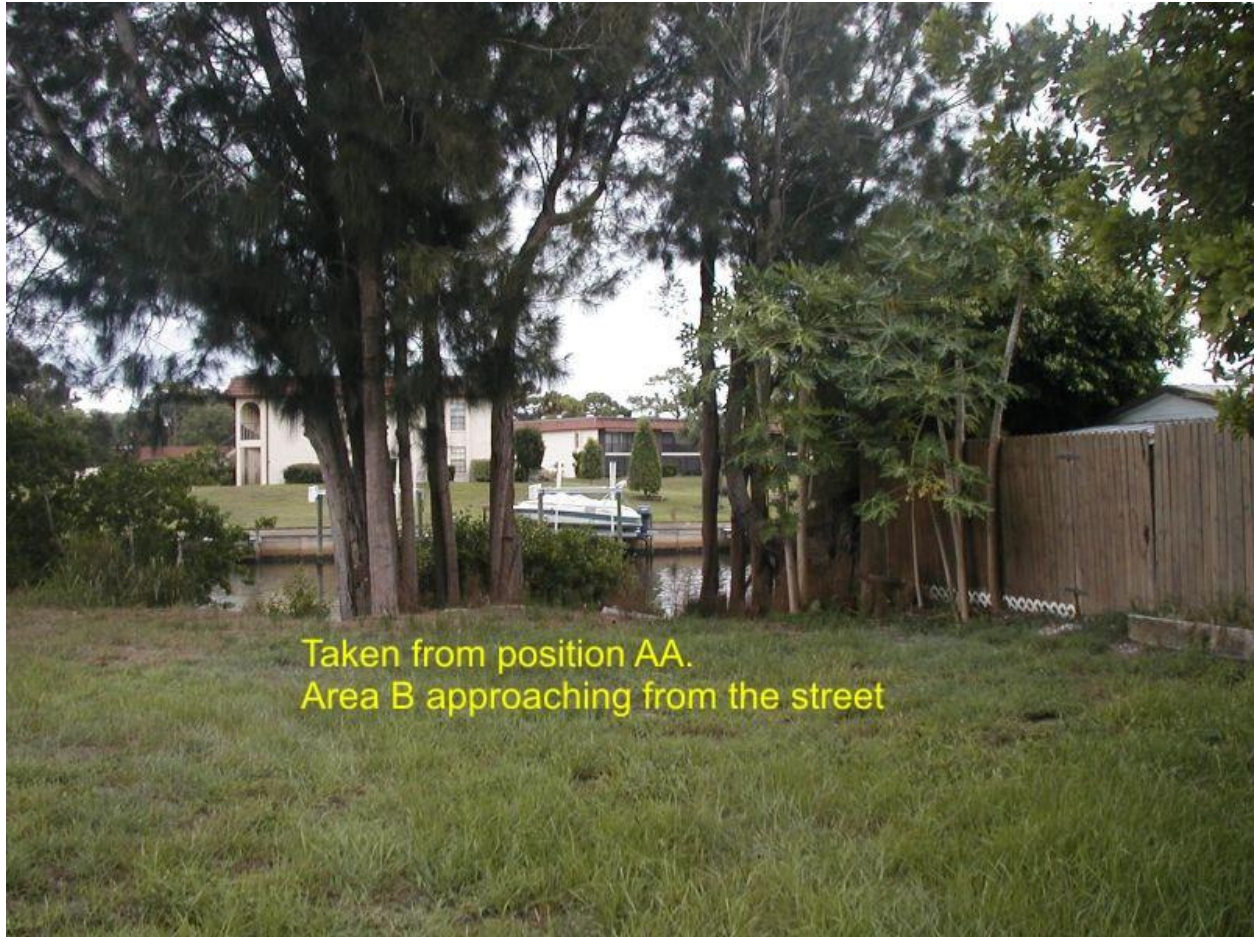
This was taken at a location half way between the carrotwood tree adjacent to the wood fence at 1309 Forked Creek Drive and the utility post 48 ft. out from the fence (location AA on the sketch). It shows the street view of the 15 large Australian pines that dominate Area B. Note that the lower Australian pine branches that were overhanging the mangroves have been removed. This was done by a contractor using chain saws, hand tools, rigging lines, and small trucks.

Area B: The lower branches of the large Australian pines and the small trees were removed. The large Australian pine branches were removed using power tools, hand tools, and rigging lines. Small trees were removed by hand tools. Shoots and seedlings were sprayed with a systemic brush killer.

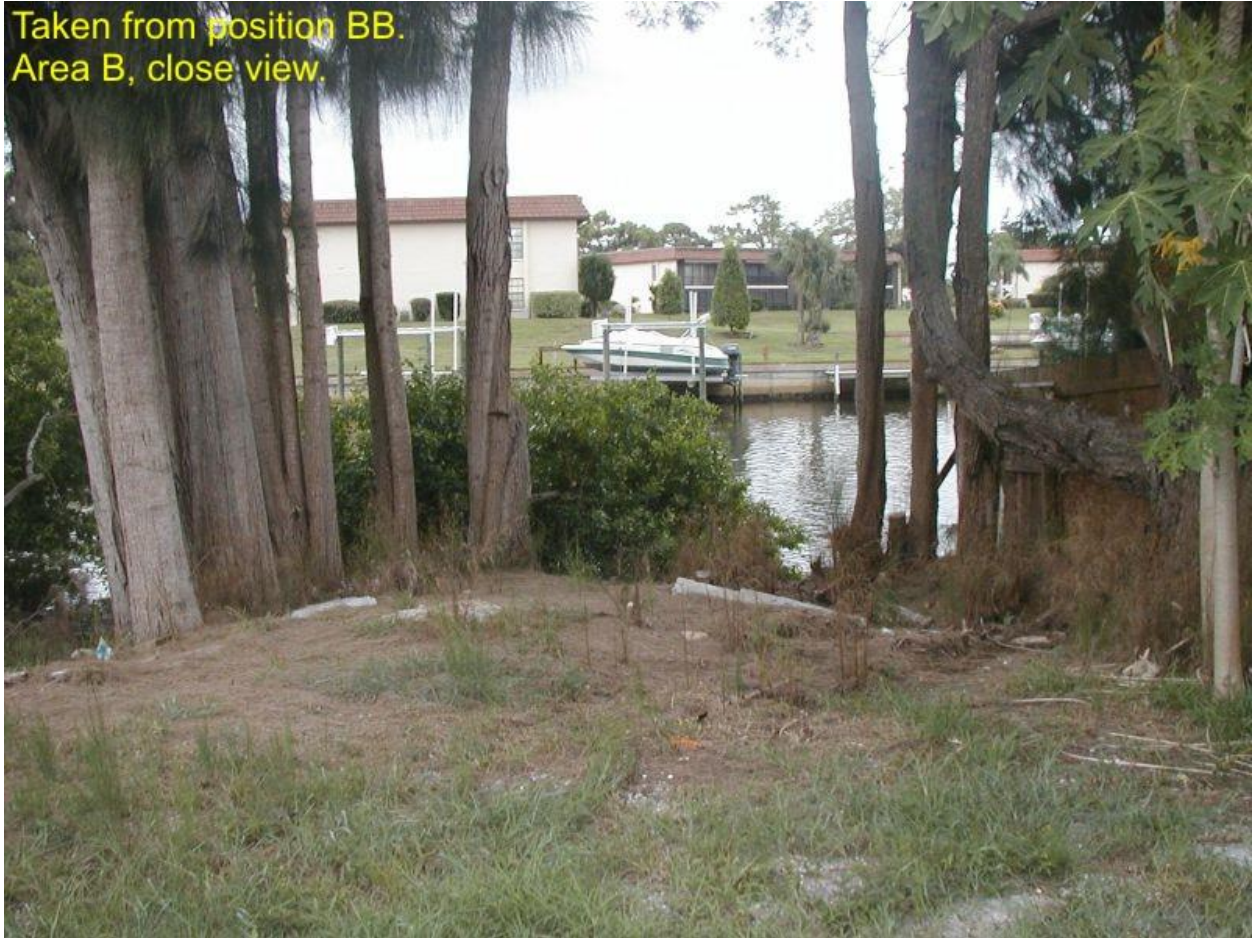
Taken from position BB.
Area B, close view.

This was taken closer to the large Australian pines to show more detail. It was taken at position BB on the sketch, 16 ft. out from the gate jam post on the wood fence on the adjacent property.

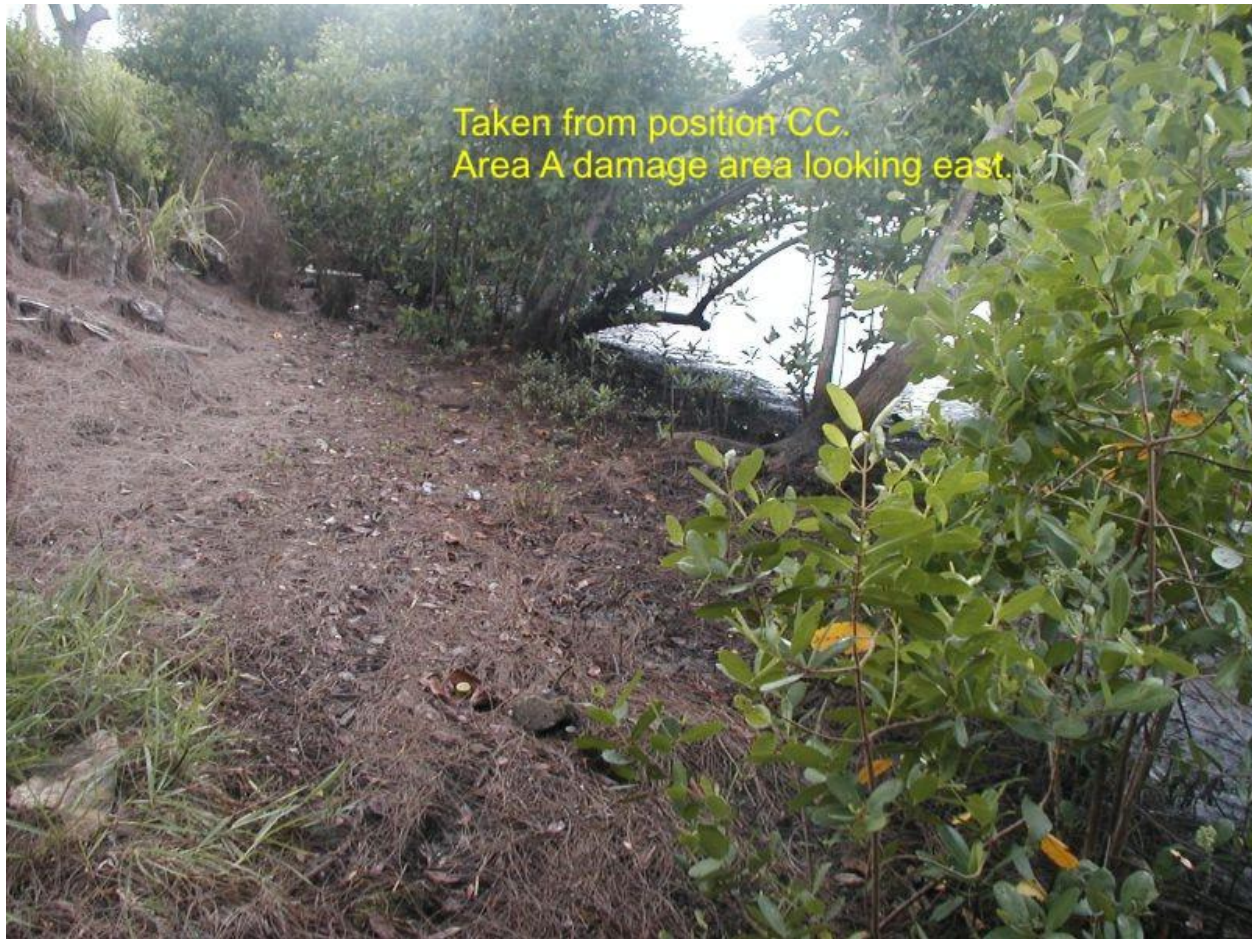
The height of the damaged mangroves ranges from about 4-19 inches. The percentage of cover is estimated to be less than 1 %.

This was taken at position CC, standing just above the low tide water line, leaning against the south most Australian pine at the west end of Area B. It shows the damage area in Area A.

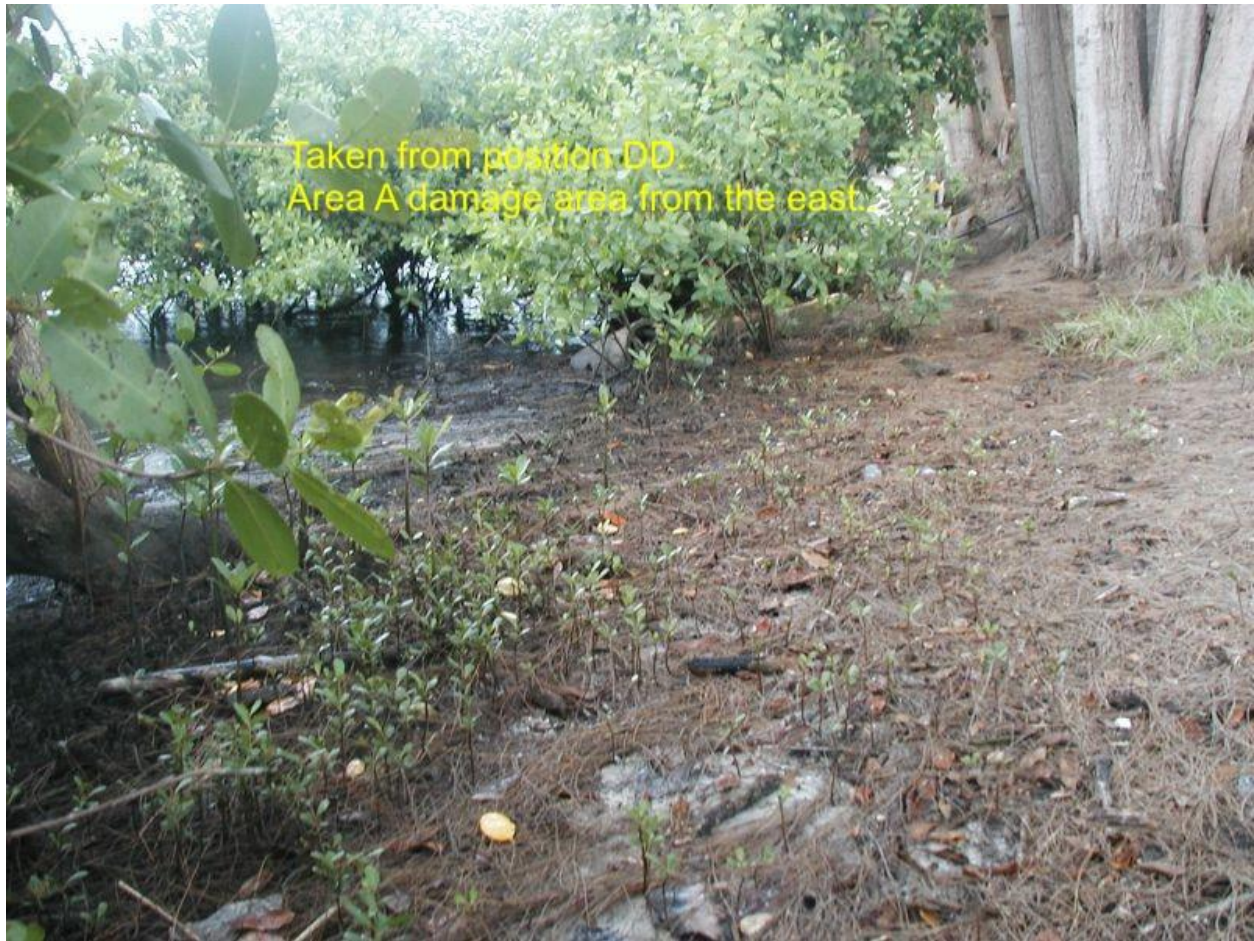
Same area of damaged mangroves as the previous photo but taken from the west at a position just below the oak tree on the bank at the east end of Area A, position DD on the sketch.
